A Field Study of the Performance of EPDM Roofing at Air Force Facilities

Prepared for:
U.S. Air Force
Air Force Engineering and Services Center
Tyndall Air Force Base
Tyndall, FL 32403

Walter J. Rossiter, Jr.
James F. Seiler, Jr.
William P. Spencer
Paul E. Stutzman

January 1991

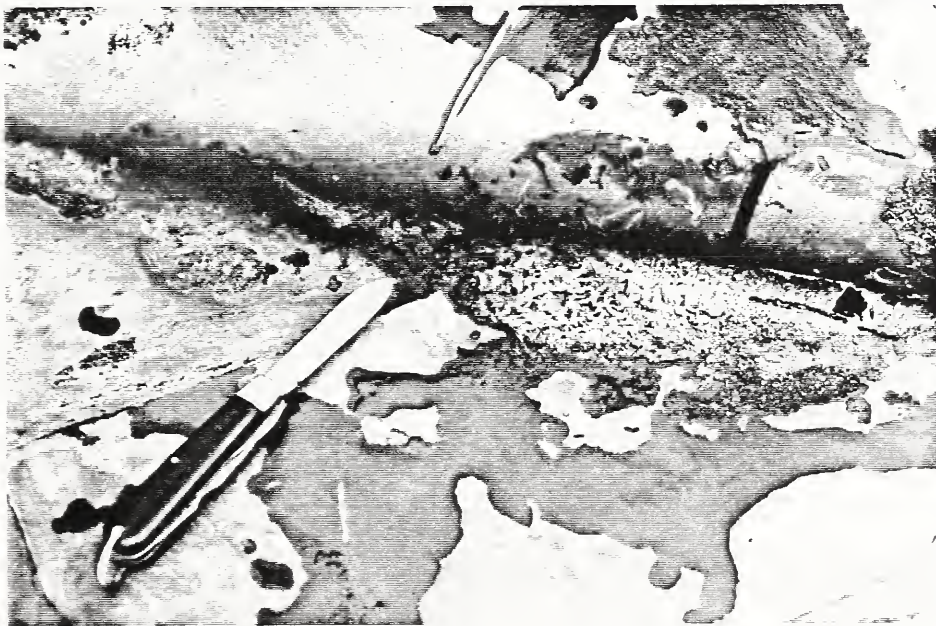
Seam problems at one building were attributed to material deterioration; at two other buildings, they were ascribed to unacceptable workmanship during installation. In the former case, seams having an adhesive reported by facility personnel to be neoprene-based³ had deteriorated, as shown in Figure 4. This roof was about 4 years old when the problem first arose. In this case, the adhesive was seen to have delaminated from the rubber, lost cohesive strength, and taken on a mushy consistency. This observation was consistent with field experiences in that seams with neoprene-based adhesives have, in some cases, deteriorated after some years in service [13,14]. Technical reports describing the problem, its extent, and factors contributing to its occurrence have not been published in the roofing literature. One short review [14] on the effect of moisture on roof system performance stated that "neoprene cements that joined individual sheets and were used as flashing cements were sensitive to elevated temperature and water."

A notable aspect of the deterioration of the seams having the neoprene-based adhesive was that it did not occur randomly over the entire roof. On the contrary, it was confined to one section, which comprised not more than 25 percent of the roof area. Moreover, patches placed over the original deteriorated seams also experienced delamination. The adhesive for the patches was also reported to be neoprene-based. To the extent that it could be determined without delaminating seams that appeared to be functioning well, the seam

Figure 4. Delaminated seam having neoprene-based adhesive

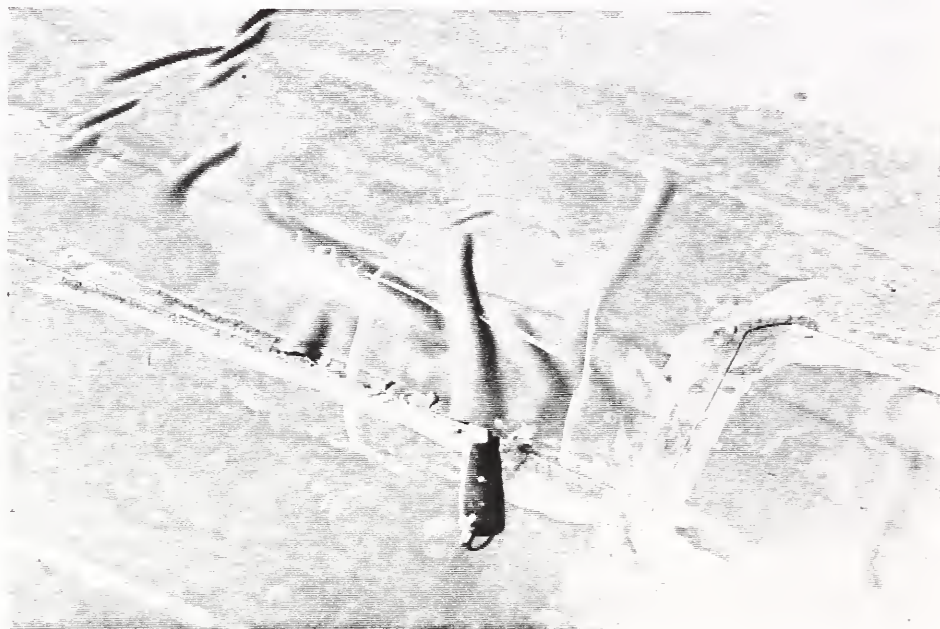
In the second case of seam problems, two roofs at the same installation (and applied by a single contractor under the same contract) that had experienced major problems; the seams contained numerous fishmouths and ripples. This was considered to be due to unsatisfactory workmanship, although the possibility that the EPDM sheets were not adequately flat or rectangular (which could have lead to ripples in their installation) could not be ruled out. Many of the ripples, but not all, bridged the entire width of the seam, and were obvious sources of leaks (Figure 5). In addition, the adhesive in the seams was extremely thick (about 50 mil or 1.3 mm). During application, thick adhesive layers retain the solvent longer than thin layers and require longer open times before the sheet surfaces bearing the adhesive can be mated together [15]. The longer retention of solvent may lead to excessive swelling of the rubber at the edges of the sheets where seams are to be made. The swelling is manifested as ripples which could, in turn, be incorporated in the seams. An example of this observation is given in Figure 6, where it is evident that the rippling is essentially limited to the seam section of the membrane. Such ripples are sources of peel stress that may delaminate the seam bond and produce leaks [16].

Figure 5. Fishmouth bridging the seam

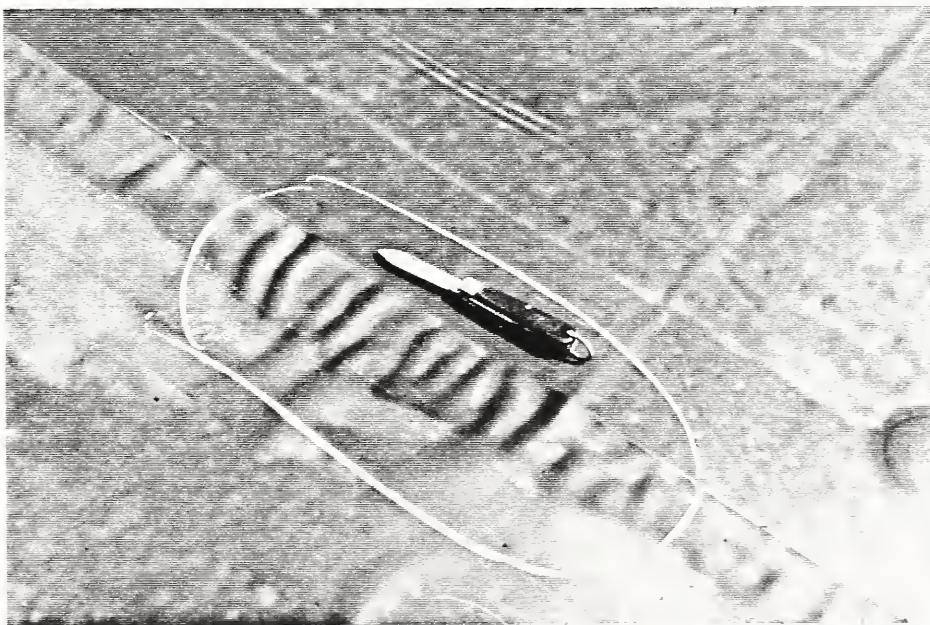
Figure 6. Ripples in the seam attributed to swelling of the rubber during adhesive application

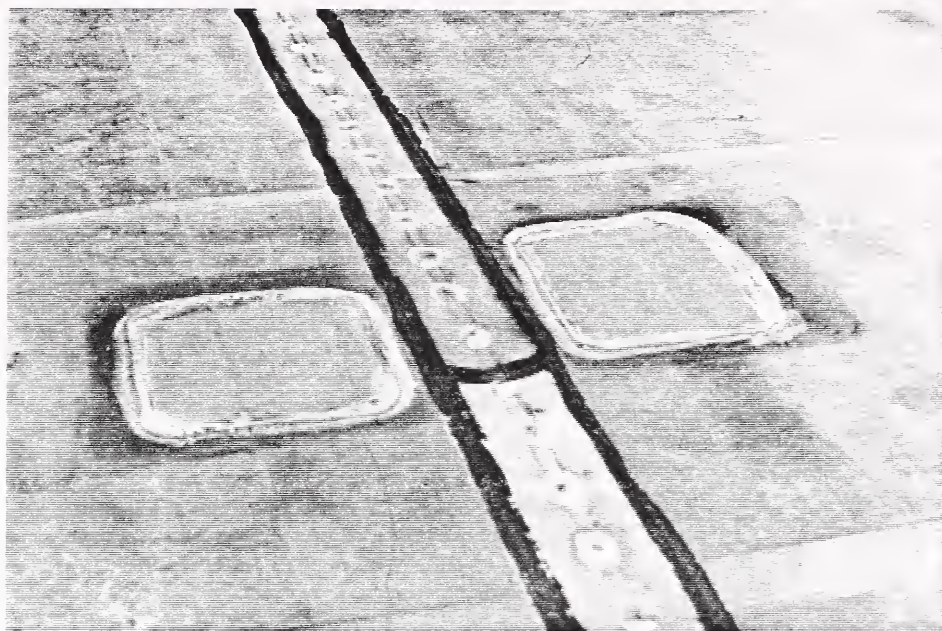
Figure 7. Patches along side of a cover strip over mechanical fasteners; the patches had performed well

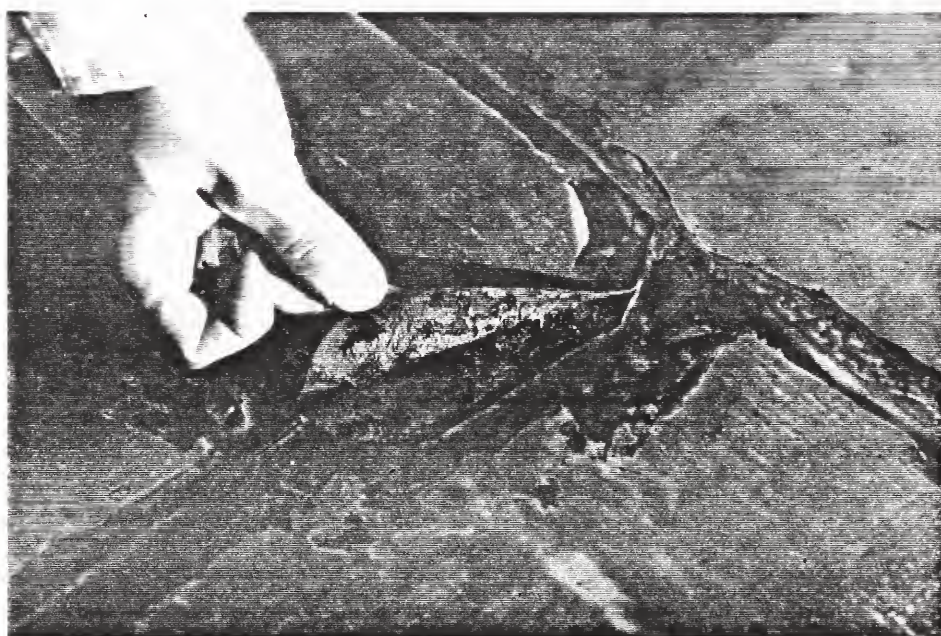
As was the case for seams, the conditions of the majority of the patches observed in the study appeared satisfactory, as probed with the tip of a blunt blade to determine whether they could be readily raised from the membrane surface. Generally, this could not be done. Figure 7 shows two patches adjacent to the covered fasteners in a mechanically attached system. They had reportedly performed well for the two years they were in service. The appearance of these patches was typical of most observed, and few patches with deficiencies (i.e., sections or edges not bonded to the membrane surface) were seen. The most significant case was the previously-mentioned roof (Section 3.4.2) where the adhesive-bonded patches over seams having neoprene-based adhesive, had also deteriorated. Such deterioration of patch adhesive was also found at two other installations (Figure 8), but the phenomenon was limited to a single patch per roof.

Figure 8. A patch with deteriorated adhesive; such observations were uncommon

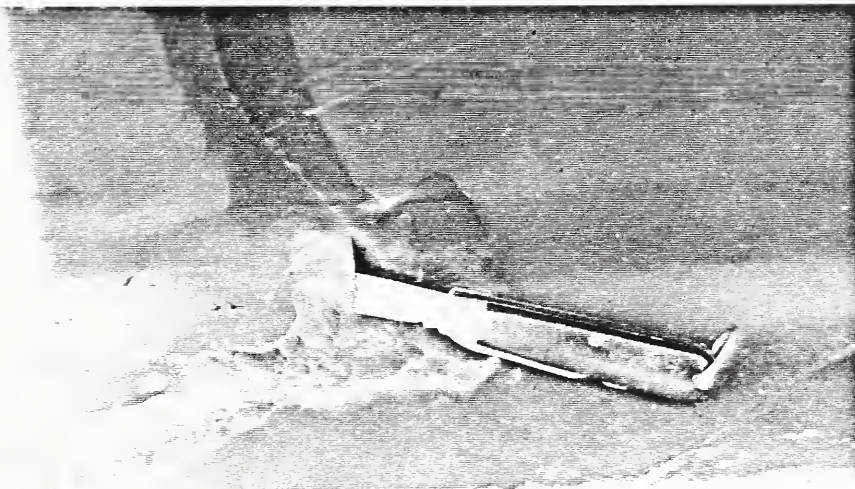
3.4.4 Flashings. The rubber base flashings observed at penetrations and perimeters of the buildings were, with one exception, in generally good condition. A common deficiency, found on a number of roofs, was a limited section of flashing which was not sealed, but contained an opening or disbond, as illustrated in Figure 9. Reasons for these defects were not always apparent but, in some cases, it was considered that the flashings had not been properly sealed when constructed. Although the observations were limited, the findings of open sections of flashing illustrate the need for good periodic maintenance inspections, and the ability for inspectors to have timely repairs made.

Figure 9. Small opening in a flashing; this was typical of many flashing defects observed

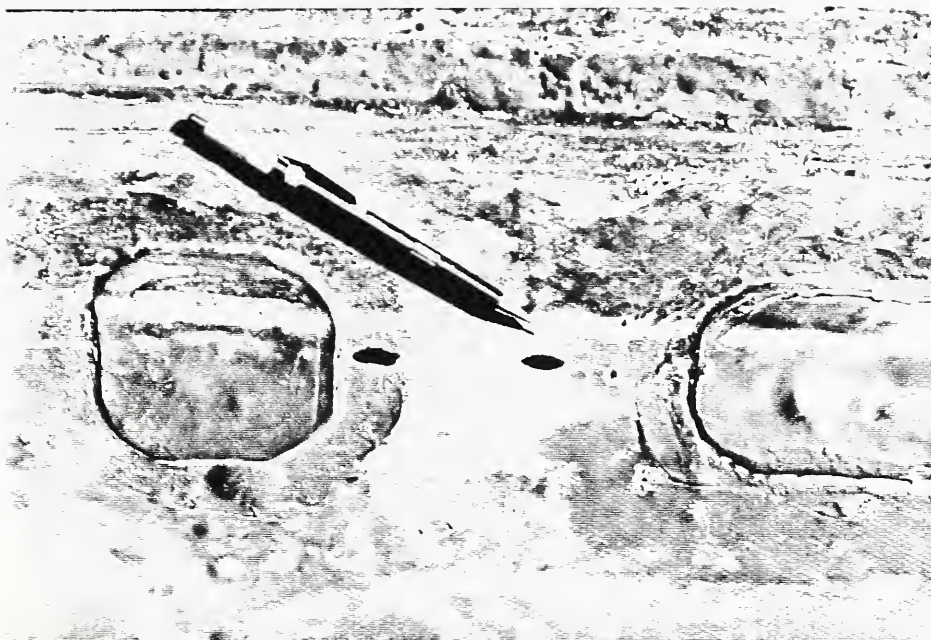
At one installation, the perimeter base flashings of a ballasted membrane system were uncured neoprene-based rubber. This flashing material had cracked extensively and randomly over the entire perimeter area during the 7 years the roof had been in place. The problem was so extensive that the ballast had been swept back from the building perimeter to have all flashing areas visible for frequent inspection (Figure 10). Many of the cracks had been patched, although some were open to water penetration into the building. The cracks were limited in length, normally a few inches (centimeters) (Figure 11). They occurred at the edge of a wooden cant strip, where the flashing was stretched tight. Apparently, this produced excessive stress in the rubber at that location, which resulted in the cracks.

Figure 11. Cracks and patches in deteriorated base flashing

Maintenance personnel at this installation normally repaired the cracks in-house by covering them with patches. Most of the patches appeared to be in satisfactory condition, while some contained small cracks similar to those in the original flashing. It was indicated to NIST staff that plans were under development to replace the perimeter flashing, because of the extensive time spent in monitoring and repairing the flashing.

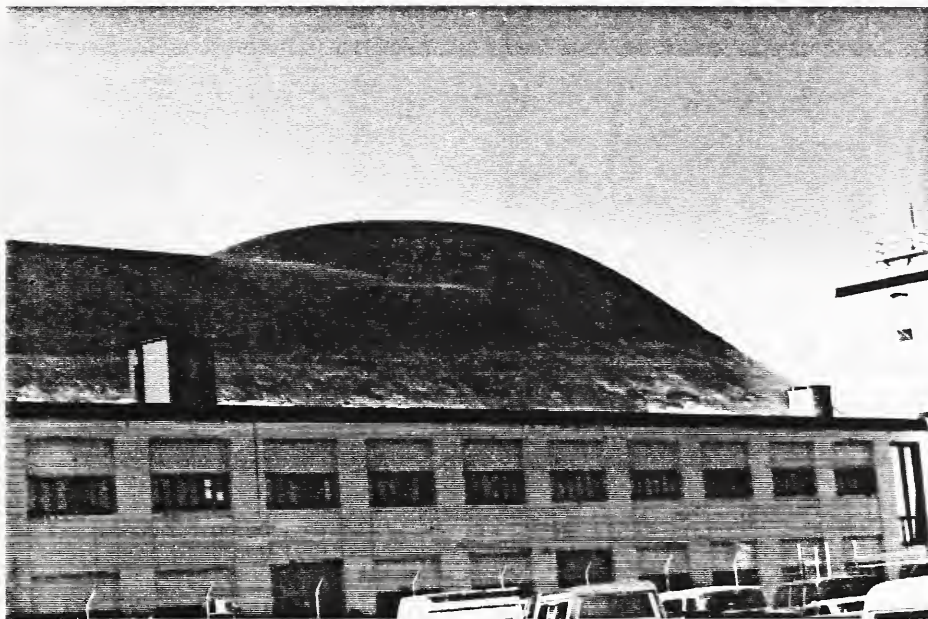
In the first, an adhered membrane was placed directly on an existing BUR system on a barrel roof of a hangar. The existing BUR membrane was apparently granule-surfaced. During high winds (speed not indicated), a section of the membrane lost adhesion to the substrate and billowed extensively, but did not blow away. Figure 13 is a photo of the billowing taken during the wind storm, and made available to NIST during the field visit. A repair was made which involved slicing open sections of the loose membrane, re-adhering it to the substrate, and seaming the areas of the slices. When the roof was inspected, the repair had been in place 4 months during which high winds had not occurred. Field personnel were concerned that the billowing problem (or worse) might recur, since they had no means to assess the adequacy of the re-bonding of the membrane to the substrate. They asked whether a test procedure was available that was applicable to both the repaired section and the undamaged section of the EPDM membrane. Standard methods to assess the adhesion of the EPDM rubber to the surface of an existing membrane have not been developed. It is possible that the ASTM Method E 907, "Field Testing Uplift Resistance of Roofing Systems Employing Steel Deck Rigid Insulation and Bituminous Built-Up Roofing," may be applicable, because it provides a measure of the adhesion between components [18]. Data supporting its applicability to the EPDM adhesion question would need to be developed.

Figure 13. Billowing of the EPDM membrane on a hangar roof during a wind storm

A topic of discussion regarding the uplift problem with this hangar roof was whether the adhered EPDM membrane should have been installed directly on the existing BUR in the first place. If the existing BUR membrane was granule-surfaced, then direct adhesion of the EPDM rubber to the BUR membrane may have been imprudent. The adhesion of the granules to the BUR membrane surface may not have been adequate to resist the uplift forces on the EPDM in the wind storm.

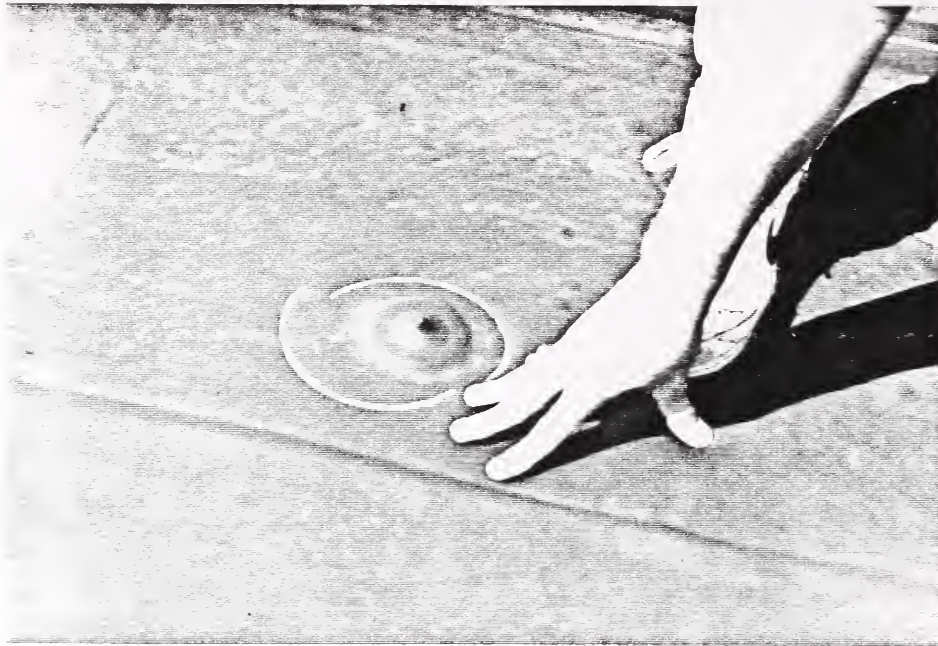
For many adhered systems, a number of observations were seen where fasteners used on insulation boards had apparently backed out and the fastener heads were pushing against the membrane. For the majority of the observations, puncturing of the membrane due to fastener backout had not occurred (Figure 14); however, in a few instances, it had (Figure 15). Backout of fasteners is a maintenance item for field personnel to consider during routine inspections.

Figure 14. Example of an isolated fastener that backed out from the deck; the membrane was not punctured

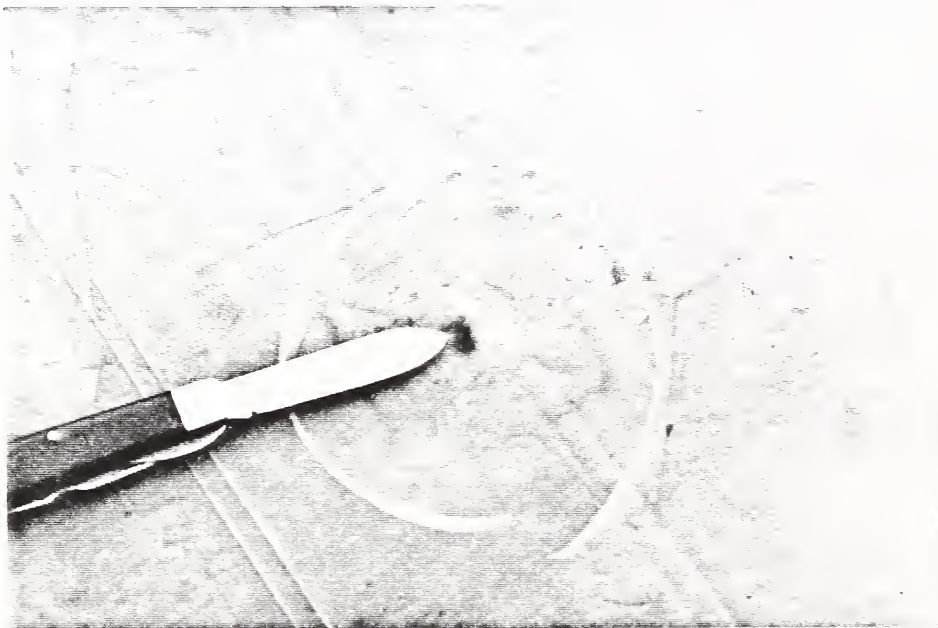
Figure 15. Example of an isolated fastener that backed out from the deck; the membrane was punctured

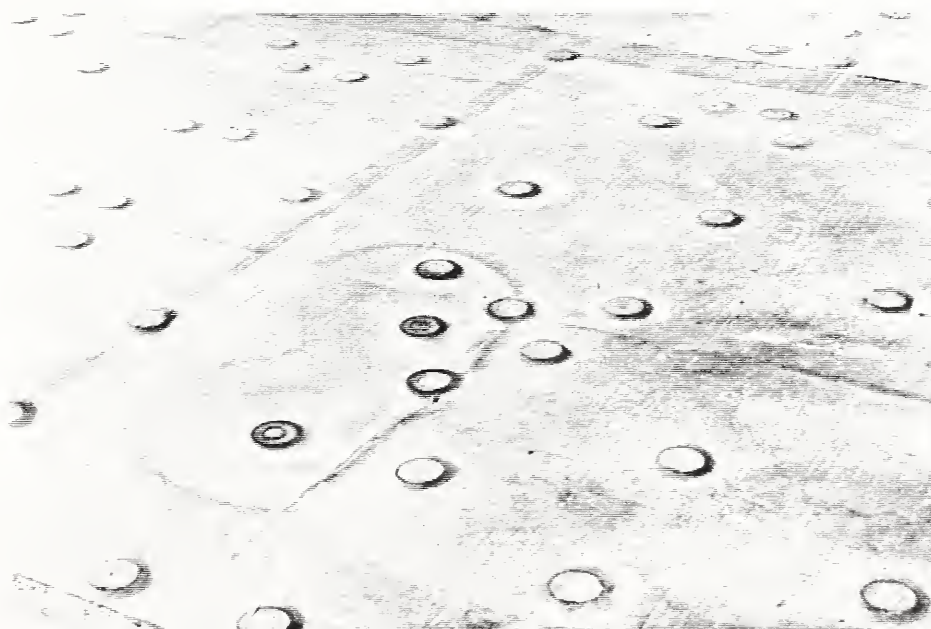
At one installation, the stress plates of mechanically fastened insulation in an adhered membrane system were set high on the top of the insulation boards (Figure 16). As a consequence, the membrane was stretched at the areas over the tops of the stress plates. In a limited, confined area (estimated to be about 10 %) of the roof, the membrane had split at the edges of some of the stress plates (Figure 17). The stretching of the membrane where the splits had occurred did not appear to be more extensive than that observed in areas without splits. Because the splitting was not random across the roof, a question was raised whether the membrane material in the areas of the splits was less resistant to stress cracking than that installed on the majority of the roof surface area. If such were the case, the risk of additional splitting occurring at other locations of the roof might be low. Nevertheless, periodic maintenance inspections should closely examine the membrane at each fastener stress plate to assure watertightness.

Figure 16. Stress plates set high on the insulation boards

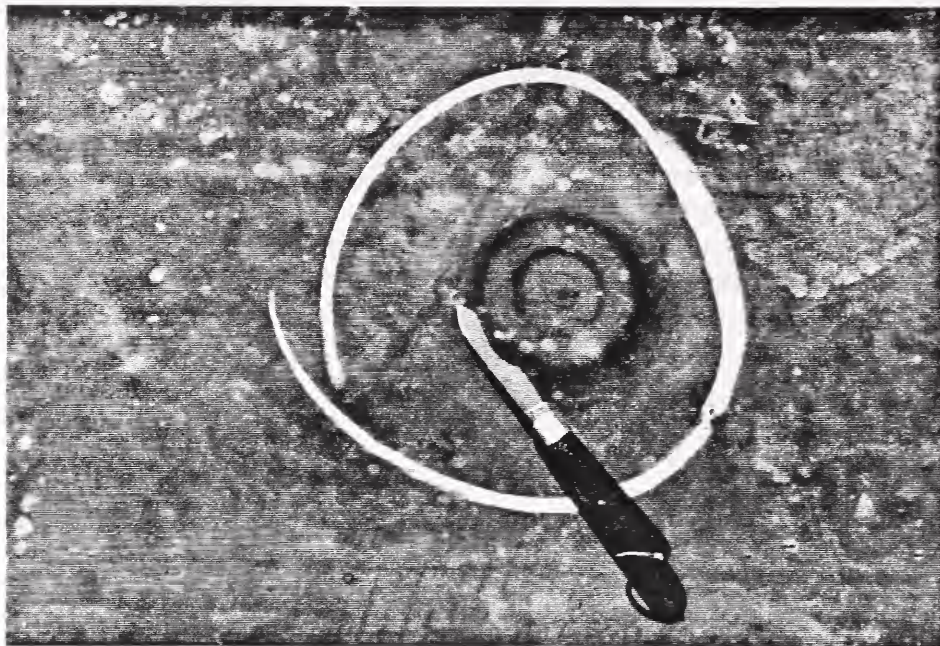
Figure 17. Split in the rubber membrane at the edge of a raised fastener stress plate

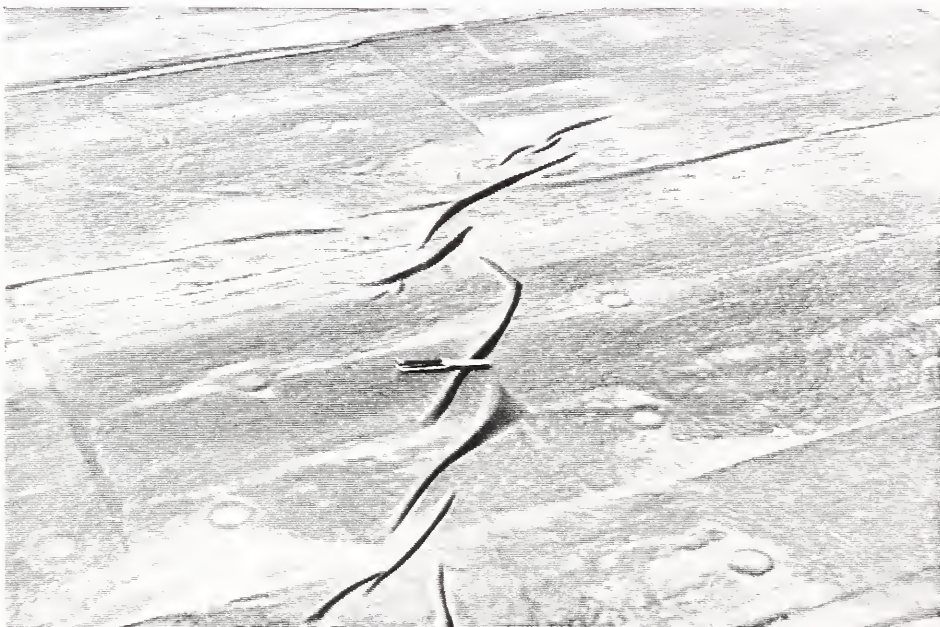
As a final point regarding adhered systems, the occurrence of wrinkles and ripples incorporated in the membrane during application is mentioned. For the majority of the roofs, wrinkles and ripples were essentially non-existent (e.g., Figures 3 & 10). However, for two roofs, they were found to be rather numerous (Figure 18). In these cases, no evidence of cracking of the rubber at these locations was found. However, if wrinkles and ripples occur in the area of seams (as discussed in Section 3.4.2), they produce fishmouths, and even if sealed tight, they subject the seams to peel stress [16].

Figure 18. Area of an adhered system with a number of wrinkles in the membrane

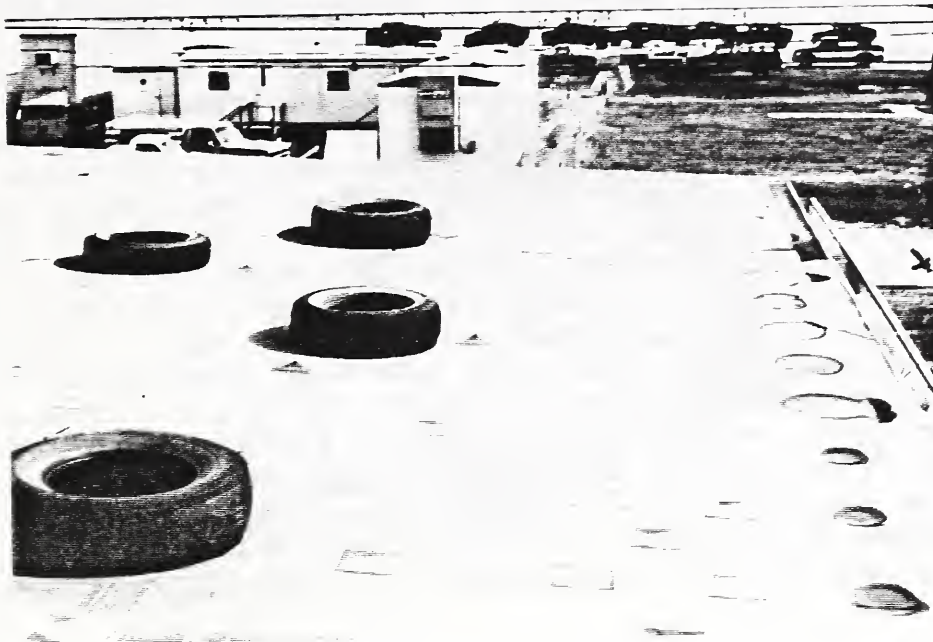
The mechanically fastened system in question used spot attachment in which each fastener was individually covered with a patch to seal the locations where the fasteners penetrated the membrane (Figure 23). In some locations on this roof, the fastener backout had been extensive enough to puncture the cover patches (Figure 24). The fastener backout had only occurred on the windward side of the building, about 10 to 20 ft (3 to 6 m) from the edge. Note in Figure 23 the position of the temporary ballast away from the edge of the building. It was at this location that the fastener installation pattern became less dense, switching from 2 to 4 ft (0.6 to 1.2 m) on centers. On the day of the inspection, a slight breeze occasionally blew. Whenever it occurred, sections of rubber membrane between the 4 ft (1.2 m) fastener spacing and in the area of the tire ballast stretched slightly and fluttered in the wind. Wind flutter resulting in fastener backout is known to occur in practice [23]. In the present case, the fluttering effect was not noticeable where the fastener pattern was 2 ft (0.6 m) on centers at the building edge where the fasteners had not backed out.

Figure 23. Used tires ballasting a section of a mechanically fastened system to provide temporary securement

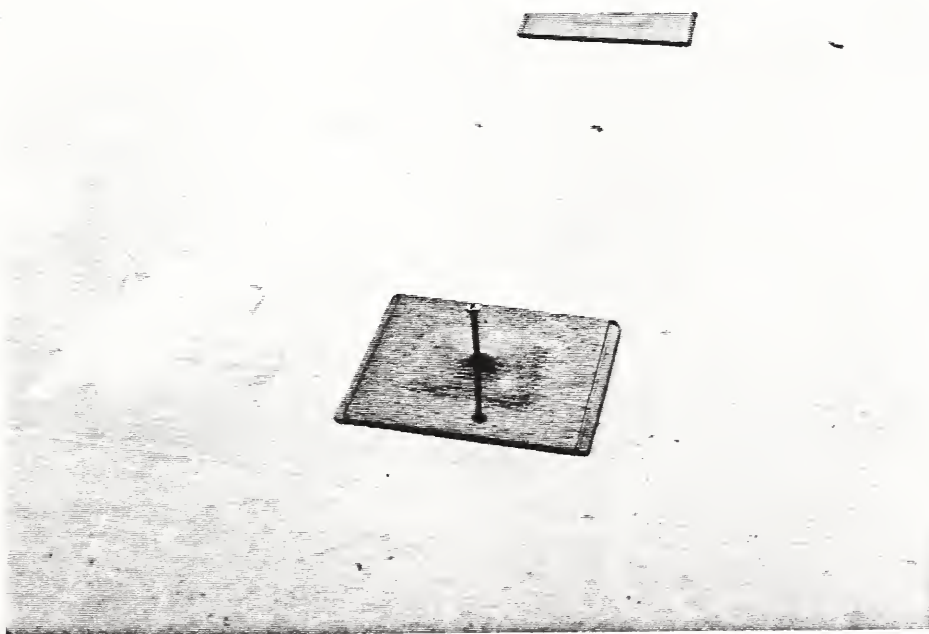
Figure 24. A backed-out fastener which punctured the cover patch sealing the penetration

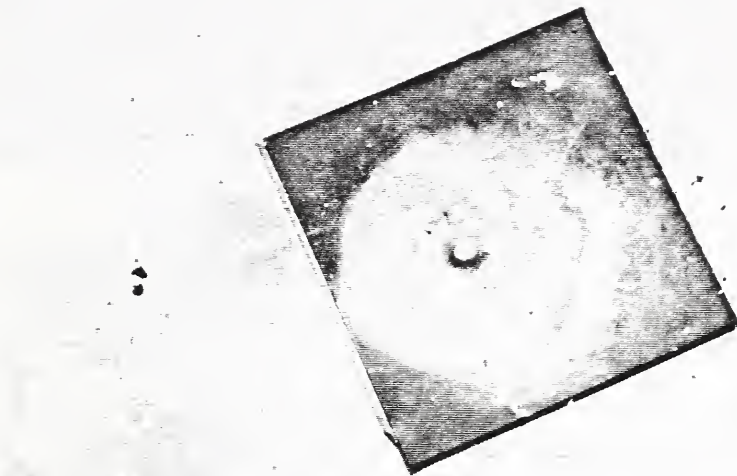
The second mechanically-fastened roof where field personnel indicated that they were not satisfied with the securement system was a spot-attached system of the type previously shown in Figure 23. In this case, the question of concern was not fastener backout, but proper sealing of the spots where the fasteners penetrated the membrane. For this system, as previously indicated, each fastener was individually covered with a patch to seal the penetrations. The concern was that many of the patches were not adequately centered over the fastener or adhered to the membrane. Figure 25 shows an off-center patch which provides little bond area on one side of the fastener plate. Figure 26 illustrates patches that were only partially adhered to the membrane. It was not known whether this latter condition resulted from unsatisfactory installation, or some disbonding of the patches after their installation. Field personnel stated that no leaks were reported in the field of the roof, indicating that the patches on the fasteners were functional in spite of the observed deficiencies. Repairs to off-center or partially disbonded patches are needed and close inspection of the system is required to assure that these patches continue to be watertight.

Figure 25. Off-centered patch over a fastener penetration; little bond area is provided on one side of the patch

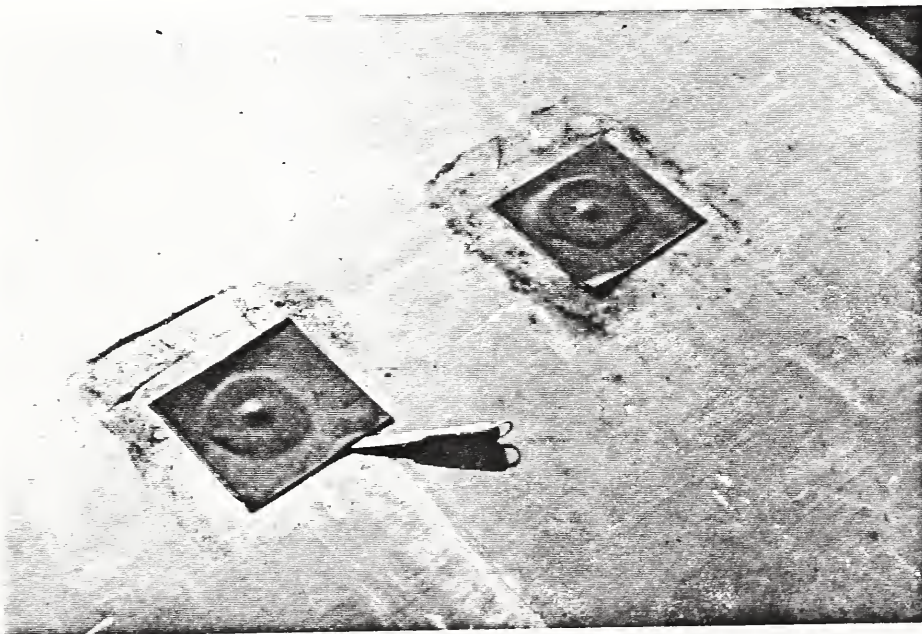
Figure 26. Lack of total adhesion of a patch over a fastener penetration

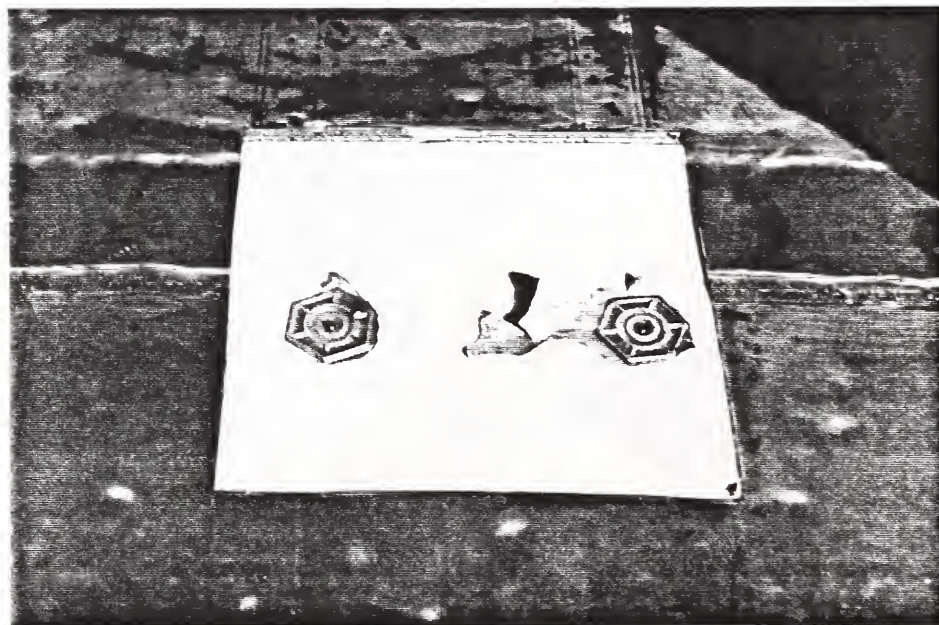
Some observations, though limited, regarding the corrosion question were made during the study. Fasteners securing insulation in adhered systems were uncovered on three buildings (one observation in each case), when seam samples were cut from the membrane. These fasteners were not removed from the roofs, whose ages were 18, 24, and 60 months. In the three cases, no visual evidence of corrosion was found on the exposed fastener heads or stress plates (Figure 27). Also no evidence of excessive moisture (e.g., liquid water) was found in the insulation. Although extremely limited, the observations concerning fastener corrosion were consistent with the general findings of the NIST review of the fastener-corrosion question [24]. In the review, it was indicated that fastener corrosion has been generally found when a roof is wet, and not found when it is dry.

Figure 27. Fastener heads and stress plates uncovered during seam sampling; no corrosion was evidenced

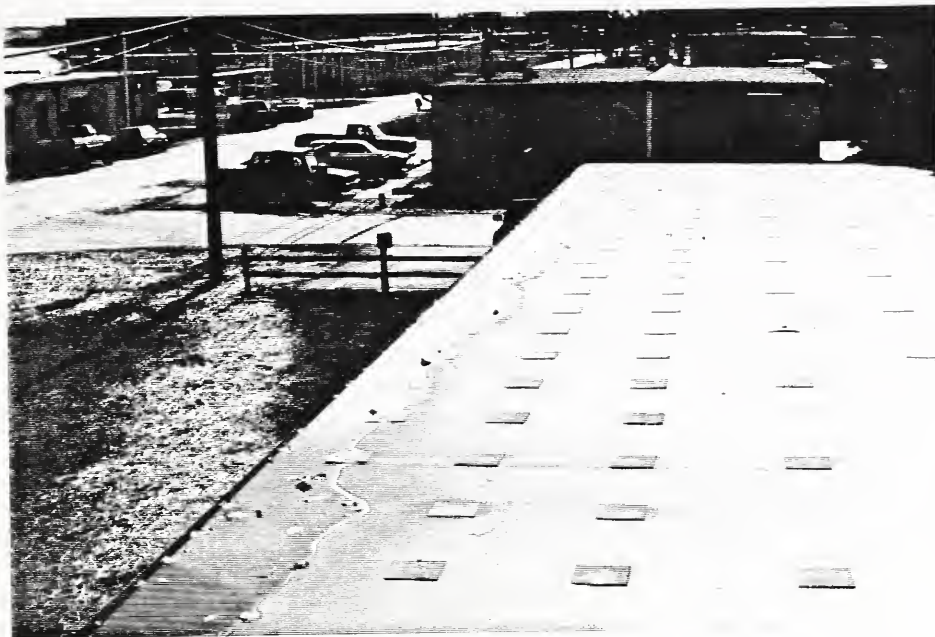
In spite of the generally good drainage, as might be expected, adequate slope did not exist over all sections of the roofs. In many cases, some areas showed indications of minor ponding, as evidenced by standing water or dirt deposited on the roof surface at locations where the water had collected and evaporated. Often, the minor ponding occurred along the edge of the roof, indicating that the slope in those locations was not sufficient. Figure 29 is an example of ponding along the roof edge. Perimeter details should consider sufficient slope to allow water to flow better over the roof edges.

Figure 29. Roof with generally adequate slope, except that ponding occurred along an edge

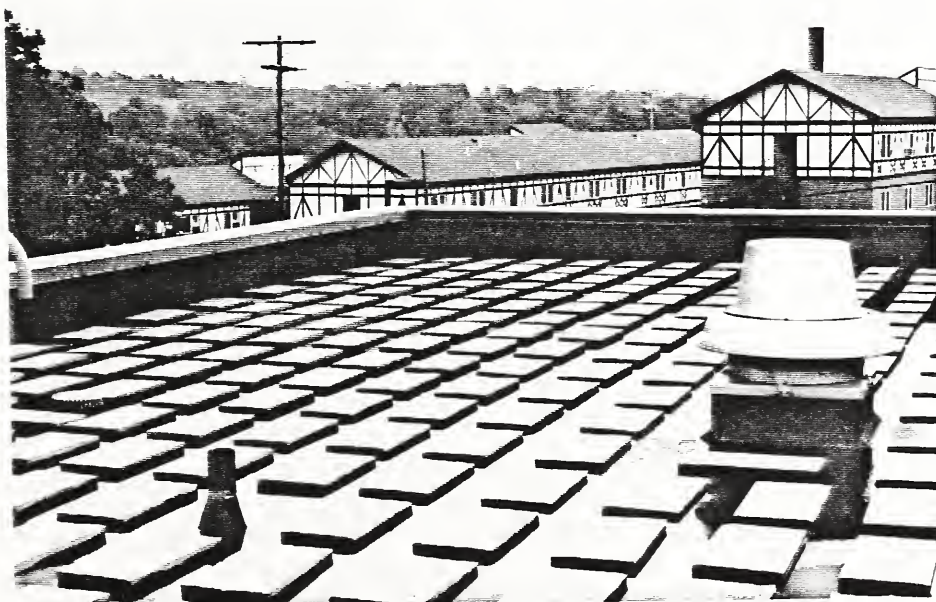
Major ponding of water was observed for one building. This roof contained a paver-ballasted membrane which was essentially totally covered with water (Figure 30). The strainer of one drain was found to be clogged with debris, but its removal did not drain the roof. The roof needs to have all the drains closely examined to determine whether they are open or not. Undoubtedly, a leak in this roof would result in considerable water entering the building. With all the water present, it was not possible to judge whether sufficient slope was incorporated in the system. Note in Figure 30, however, that the height of the two parapet walls does not apparently change across the edges of the building. It was not known whether the ballast caused undue deflection of the roof, and thus contributed to the ponding. However, as is seen in Figure 30, the pavers were not continuous across the field of the roof. A question raised was whether the partial covering of the membrane surface with pavers was done because the roof could not sustain total coverage. This roof was 8 years old and had reportedly performed well over this time. Field personnel indicated that leaks, attributed to flashing problems where two sections of the building tied together, had occurred but were repaired. Since then, the roofing was reported to be leak-free.

Figure 30. Extreme ponding of water on a ballasted system

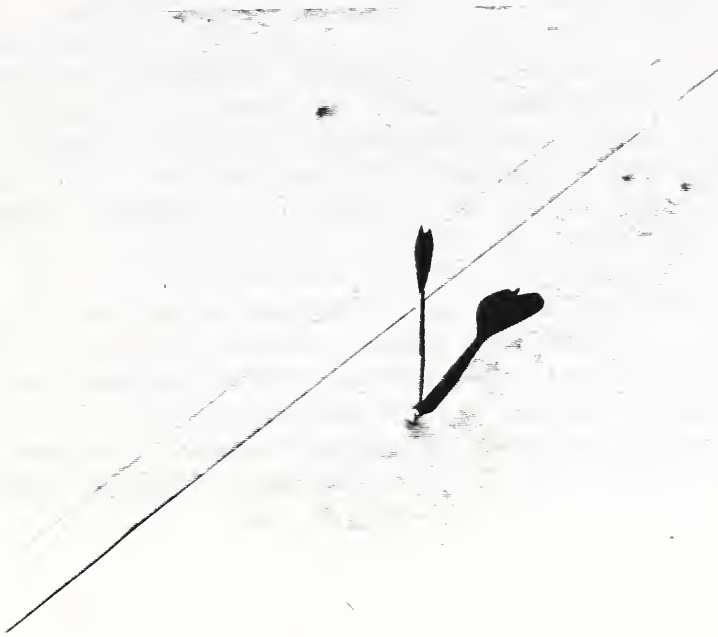
Figure 31. Example of abuse to an EPDM membrane; a dart was found stuck in its surface

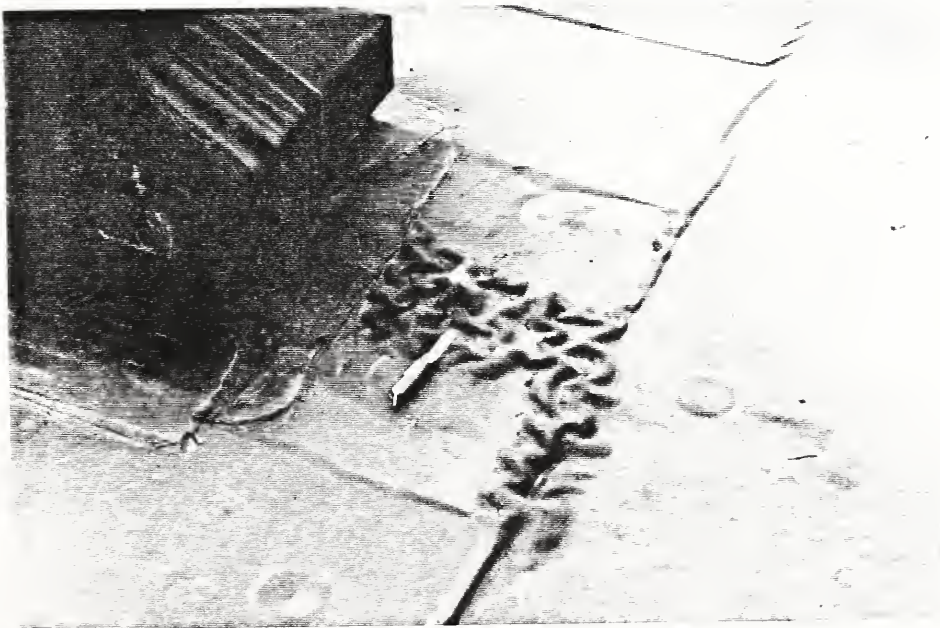
- o oil from mechanical equipment or grease from kitchen appliances were discharged directly on EPDM surfaces (Figure 32); the membranes were seen to be swollen due to the oil or grease. In the cases observed, it was noted that the swelling damage to the membrane was somewhat localized at the spot of the discharge. Apparently, neither flowing of the oil or its washing by rainwater spread the damage over large sections of the EPDM membrane. This suggested that lamination of an oil or grease resistant rubber to the EPDM membrane at the spot of discharge might prevent the local damage.

Figure 32. Oil effluent from a ventilator swelling the EPDM rubber membrane

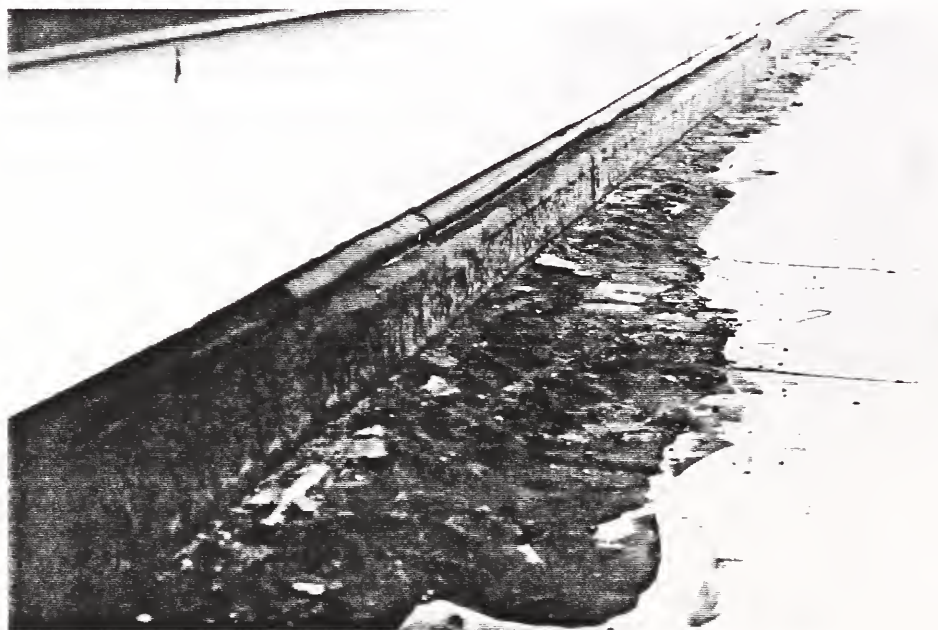
- o the use of asphaltic mastic (plastic cement) as an intended repair material. This was found on isolated spots of four roofs (Figure 33), presumably in attempts to stop leaks. The solvents in these mastics swell EPDM rubber, similarly to the action of some oils discharged from equipment. In cases where mastic was observed, USAF engineering personnel accompanying NIST staff were aware that these solvent-bearing materials should not be used on EPDM. They considered that uninformed shop personnel used the mastics on EPDM in a repair manner that might be routinely done for bituminous roofing. The observations concerning the improper use of mastics illustrate the concerns expressed by field personnel that training and guidelines are needed for the maintenance and repair of EPDM roofing at USAF installations.

Figure 33. Swelling of the membrane due to the application of asphaltic mastic in an attempted repair

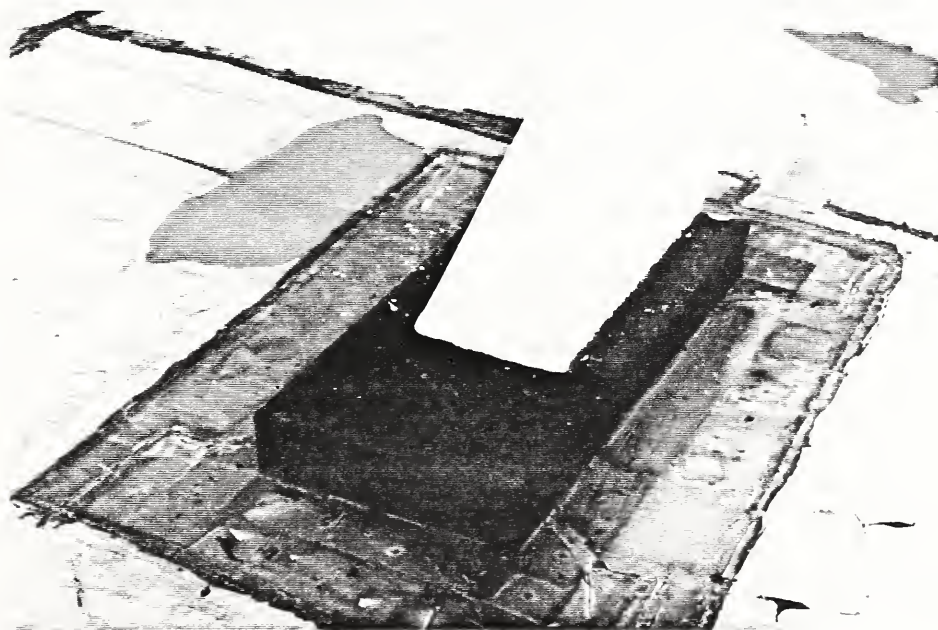
Few pitch pans were observed on the USAF roofs inspected. Where pitch pans were present, they were found to be full of elastomeric sealant which was crack-free and pliable to the touch (Figure 34). The ages of the roofs with the pitch pans ranged from 38 to 68 months. Routine maintenance should include pitch pan inspections to assure that they remain functional.

Figure 34. Pitch pan filled with elastomeric sealant
